Sudden loss of the deep brain stimulation effect with high impedance without macroscopic fracture: a case report and review of the published literature

Hui-Jun Yang¹
 Ji Young Yun²
 Young Eun Kim³
 Yong Hoon Lim⁴
 Han-Joon Kim⁵
 Sun Ha Paek⁴
 Beom S Jeon⁵

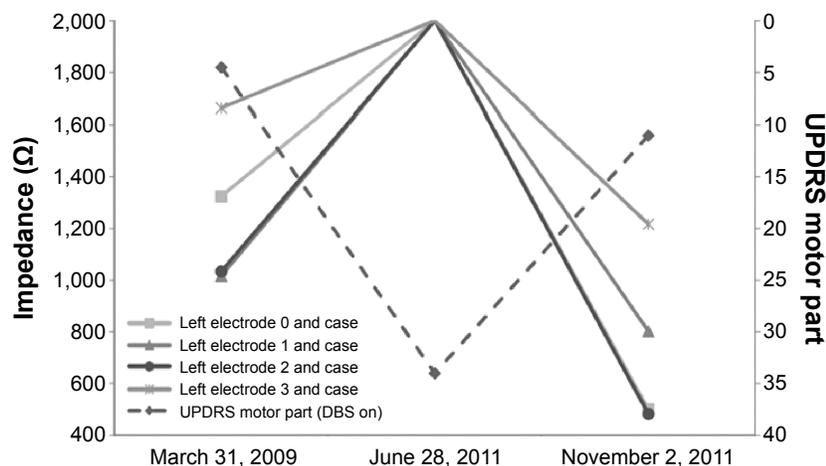
The patient was well until December 24, 2010, when she awoke with an abrupt worsening of her parkinsonism with no clear precipitant. Five days later, she visited our movement disorder center. On testing, the battery voltage levels were intact. Impedances were increased to >2,000 Ω in all four lead contacts on the left side, indicative of an open circuit. The results did not change in multiple body positions.⁵

Prior to reoperation, her UPDRS motor scores with DBS stimulation were 34 with medication and 30 without (Figure 1). The scores without stimulation were 48 and 45, respectively. On June 29, 2011, the IPG was replaced under local anesthesia without any complications. Postoperatively, the patient's parkinsonian symptoms immediately improved under the same neurostimulator settings. The lead impedance readings on the left side were normalized. The extracted neurostimulator showed no visible signs of deformity. When tested with an oscilloscope at 1,000-Ω load impedance, the neurostimulator could produce stimulation waveforms. The destructive analysis by the manufacturer revealed that the case feed-through wire was lifted on the hybrid side, and this finding was consistent with the disconnection between the IPG hybrid circuit board and the connector block of the IPG header.

During a follow-up period of 4 months with amantadine at 300 mg/day, no recurrence of parkinsonian symptoms or high impedance measurements were reported. On November 2, 2011, her UPDRS motor scores were 11 with DBS stimulation and 34 without (Figure 1). In the 2 years after

Figure 1 Changes in lead impedances and UPDRS motor part scores before and after neurostimulator replacement. **Abbreviations:** DBS, deep brain stimulation; UPDRS, unified Parkinson's disease rating scale.

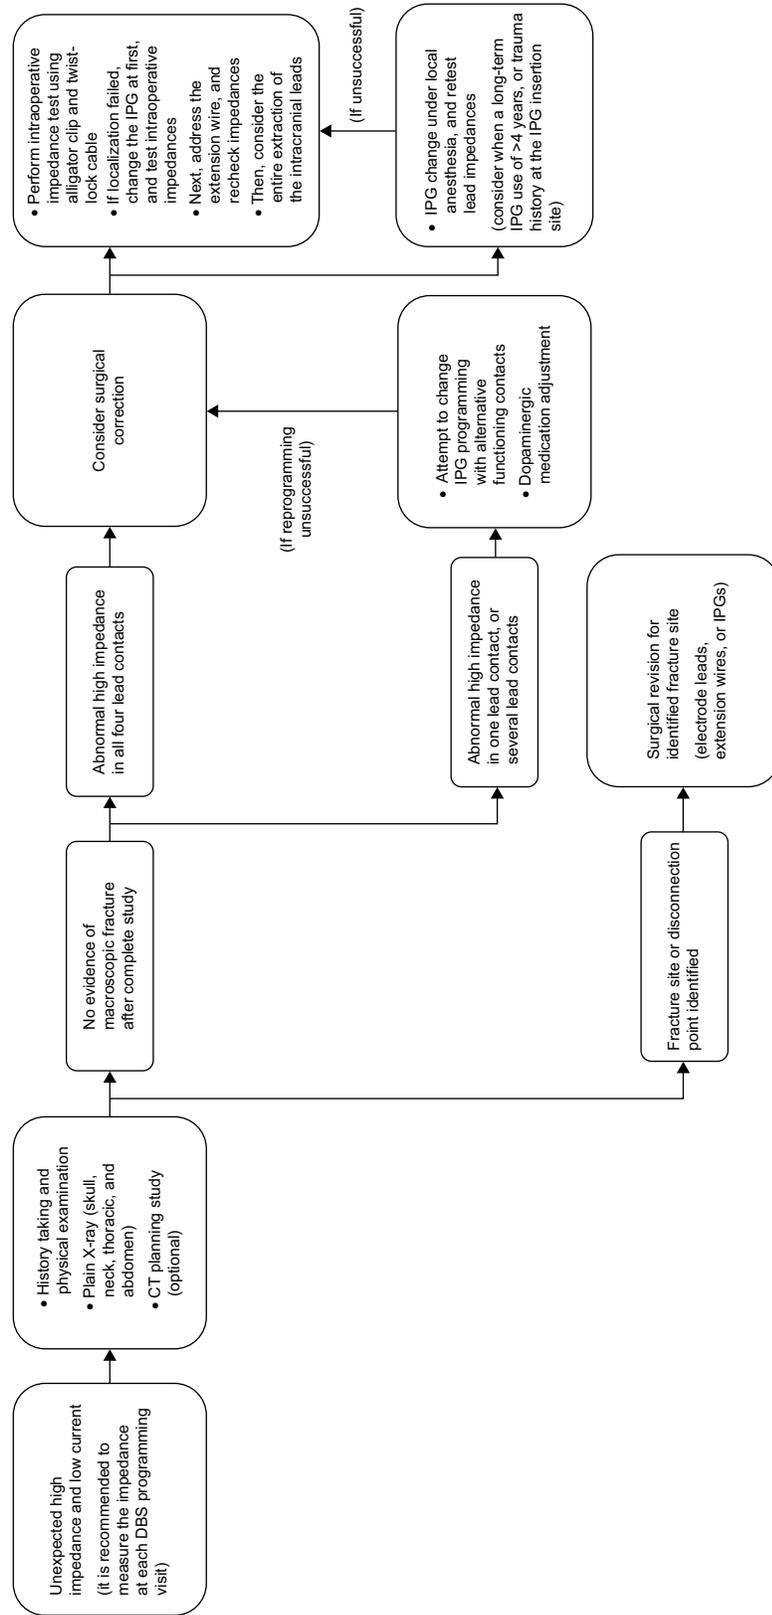
In cases of abnormally increased lead impedance and open circuit without a macroscopic fracture, the optimal treatment options are still not established. A proposed algorithm for assessing and troubleshooting those specific cases is presented in Figure 2.^{1,2,6,17} Conventional IPG replacement under

Figure 2 A suggested algorithm for assessing and troubleshooting hardware failures with high lead impedance and open-circuit state in a DBS system.

local anesthesia is simple, and it can be performed in cases with unexplained high lead impedance before the decision is made to replace the electrode leads or extension wires. This approach may be preferred in patients with either a long-term IPG use of more than 4 years,²⁰ or a trauma history at the neurostimulator insertion site (Figure 2).^{8,15} On the other hand, some cautionary notes should be sounded. The neurostimulator replacement procedure can cause several complications, such as infection or damage to the lead extender. If there is no clinical improvement after the IPG change, the extension wire replacement with a direct intraoperative testing of the intracranial leads during surgery should be the next step of management (Figure 2).^{1,6,14} This staged approach can spare intact leads and extensions, and avoid unnecessary replacements and complications.
